| Job Title | UANT Cancer Center | Customer | Skiles Group | Art | C. Peterson | APPROVAL _____ Client Approval Date _____ |
| Location | 801 W. Interstate 20 | Drawing # | 3849A | Date | 04/20/2009 | |

Wall Connection Detail

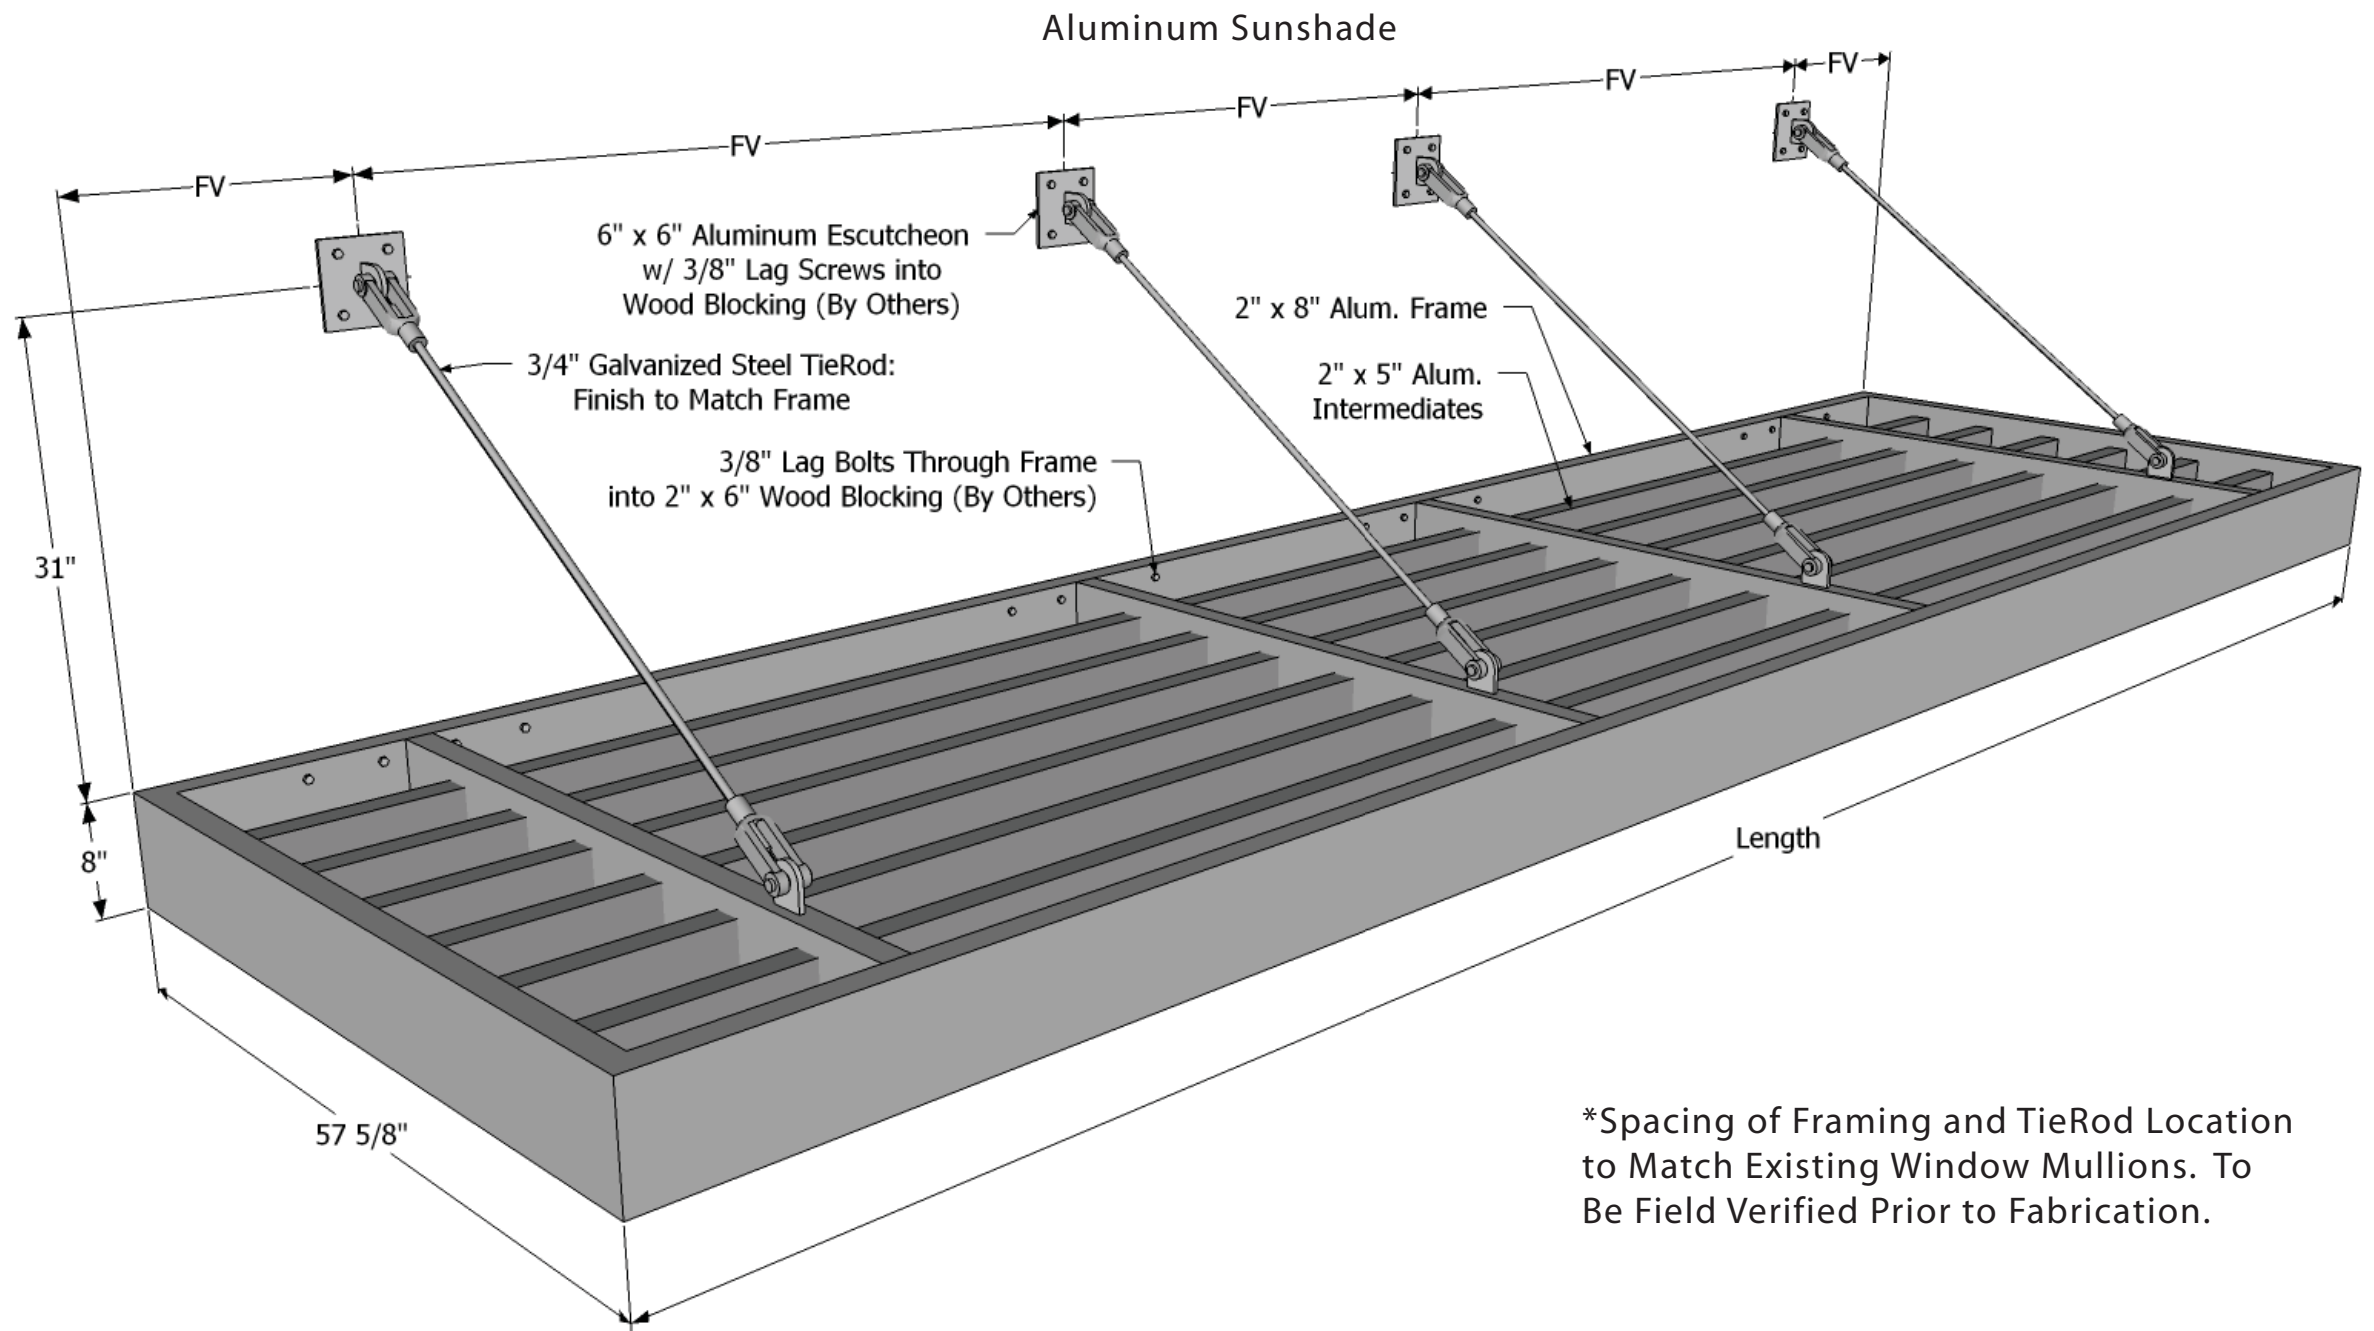
*Spacing of Framing and TieRod Location to Match Existing Window Mullions. To Be Field Verified Prior to Fabrication.
